**Flood Control Project Maintenance  
Levee Inspections**

**Spring 2016 Levee Inspection Results**

**Madera County FCWCA**

Waterway			Bank	Unit Miles
Unit No. 01 Ash Slough			Right	2.37
	Spring (March - May)	Summer (June - August)	(September - November) Fall	Winter (December - February)
Unit Maintenance Rating (Fall Only)				
Date of Inspection	4/14/2016 - 4/14/2016			
DWR Inspector	Herman Phillips			
Accompanied By	Dario Dominguez Madera Co. Public Works Dept.

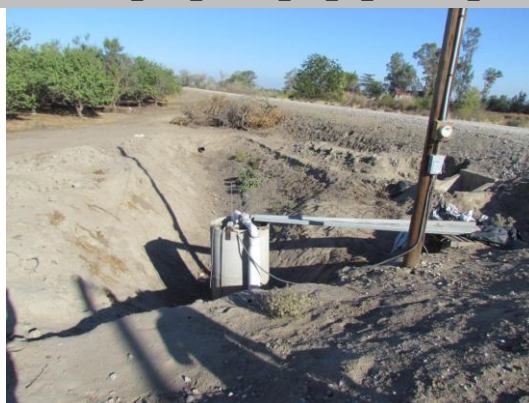
Photo 1 of 1 : SP\_2016\_NA0011\_142\_18\_20160223\_00003.jpg

LM Start	0.03	Rating **	U	Issue No.	18
LM End	0.06	Issue Type +	En	Location *	LS
Category	Earthen Levee			GPS Latitude/Longitude	
				Start	End
Item	Encroachments			37.046566 °	37.046715 °
				-120.427512 °	-120.426964 °
DWR ID	DWR_NA0011_01_s_2014_18				
Comment Code					
DT : Ditch					
Inspector Comment					
There seem to be lots of activity going on at this location. This ditch will cause more damage to the levee slope and toe.

Irrigation ditch within the landside levee toe.

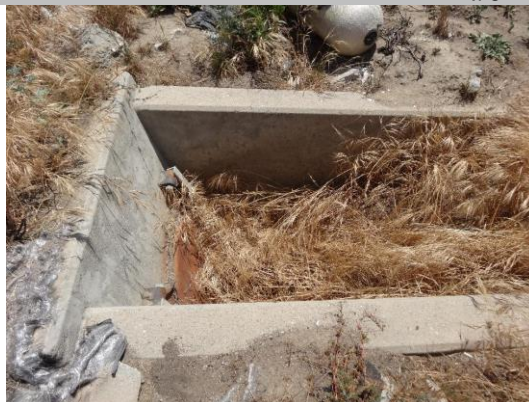
Photo 2 of 2 : UCIP\_SP\_2016\_42856\_69673.jpg

Flap gate located on waterward side blocked by dense vegetation.

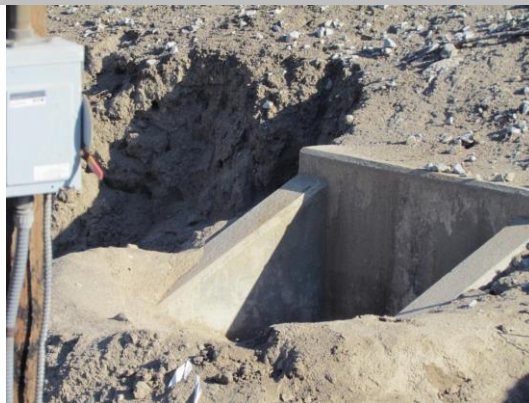
Photo 1 of 1 : SP\_2016\_NA0011\_142\_20\_20160223\_00004.jpg

LM Start	0.04	Rating **	U	Issue No.	20
LM End	0.05	Issue Type +	Ma	Location *	LS
Category	Earthen Levee			GPS Latitude/Longitude	
				Start	End
Item	Slope Stability			37.046624 °	37.046682 °
				-120.427317 °	-120.427108 °
DWR ID	DWR_NA0011_01_s _ 2014_20				
Comment Code					
S1 : Repair slope instability.					
Inspector Comment					
This is not a new erosion site, it should be repaired before the condition get any worse.

There is damage to the landside slope near the concrete wing wall.

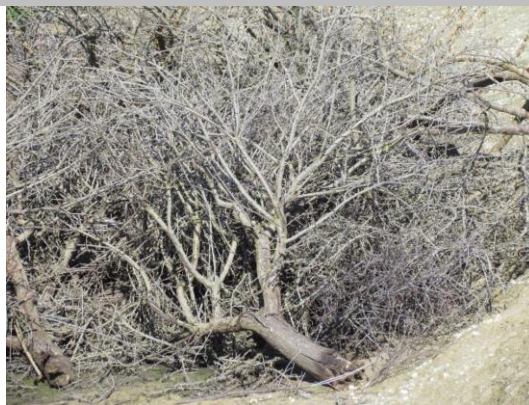
Photo 1 of 1 : SP\_2016\_NA0011\_142\_19\_20160426\_00022.jpg

Looking upstream from the landward toe Tree trimmings covering the slope and toe

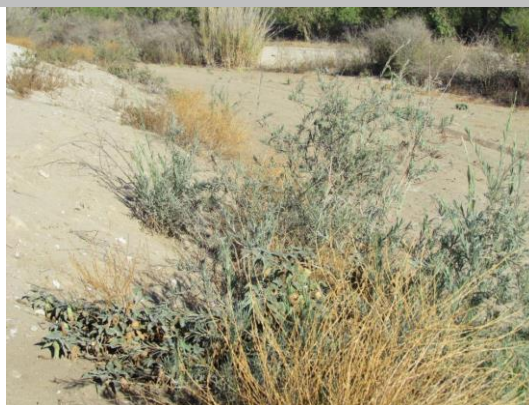
Photo 1 of 3 : SP\_2016\_NA0011\_142\_38\_20160223\_00008.jpg

LM Start	1.17	Rating **	U	Issue No.	38
LM End	1.37	Issue Type +	Ma	Location *	WS
Category	Earthen Levee			GPS Latitude/Longitude	
				Start	End
Item	Slope Stability			37.056380 °	37.058520 °
				-120.412483 °	-120.410257 °
DWR ID	DWR_NA0011_01_f_2015_38				
Comment Code					
S3 : Repair the levee slope damaged by vehicle traffic and prevent access where possible.					
Inspector Comment					
The slope will have to be put back in place damaged by equipment.

The levee slope has been damaged by equipment, the farmer has cut the toe away while working too close to the levee.

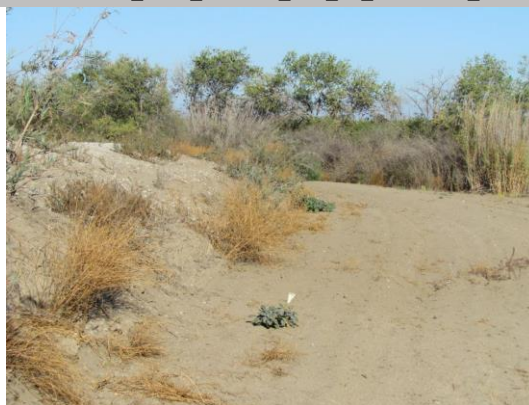
Photo 2 of 3 : SP\_2016\_NA0011\_142\_38\_20160223\_00009.jpg

Another view of the damaged toe.

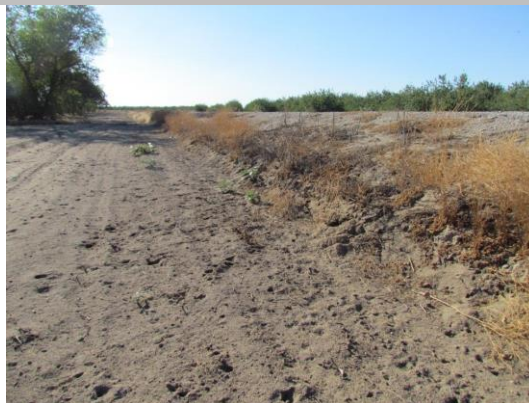
Photo 3 of 3 : SP\_2016\_NA0011\_142\_38\_20160223\_00010.jpg

LM Start	1.17	Rating **	U	Issue No.	38 (cont)	
LM End	1.37	Issue Type +	Ma	Location *	WS	
Category	Earthen Levee			GPS Latitude/Longitude		
				Start		End
Item	Slope Stability			37.056380 °		37.058520 °
				-120.412483 °		-120.410257 °
DWR ID	DWR_NA0011_01_f_2015_38					
Comment Code						
S3 : Repair the levee slope damaged by vehicle traffic and prevent access where possible.						
Inspector Comment						
The slope will have to be put back in place damaged by equipment.

Slope damage at toe of the water side levee section.

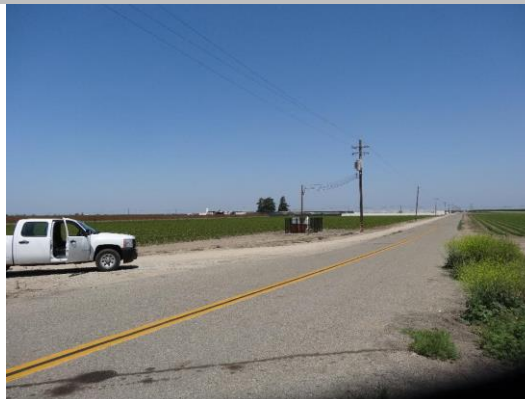
Photo 1 of 2 : UCIP\_SP\_2016\_39845\_71800.jpg

Pump station visible approximately 100 feet from concrete standpipe.

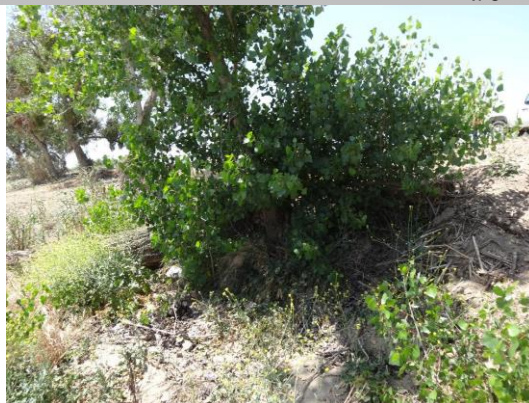
Photo 2 of 2 : UCIP\_SP\_2016\_38226\_69678.jpg

View of waterward slope--no signs of crossing visible.

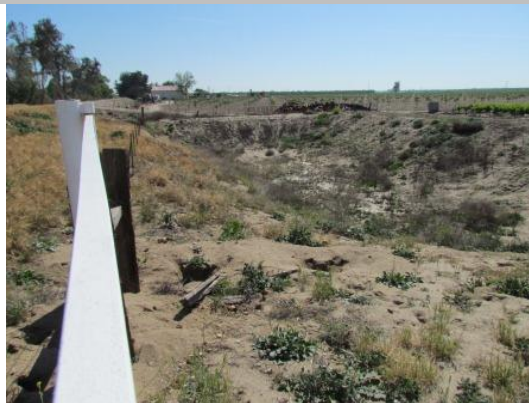
Photo 2 of 2 : SP\_2016\_NA0011\_143\_32\_20160223\_00007.jpg

Ash Slough at levee mile 0.01-0.03 there is a settling basin on the landside. First reported this issue on 2012 levee inspection. Photo taken 4-29-2014.

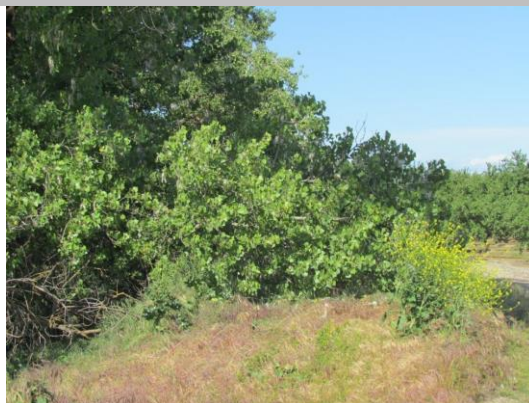
Photo 1 of 1 : SP\_2016\_NA0011\_143\_17\_20160426\_00043.jpg

Looking upstream from levee mile 0.14 fallen tree blocking access along the crown roadway.

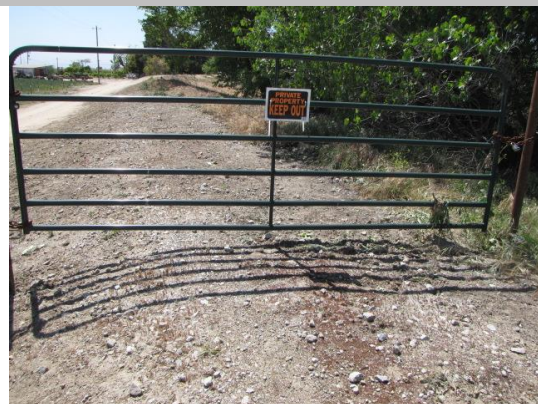
Photo 1 of 1 : SP\_2016\_NA0011\_143\_5\_20160223\_00003.jpg

Unauthorized gate and metal fence placed on slope and toe of levee section. Photo taken 4-17-2013.

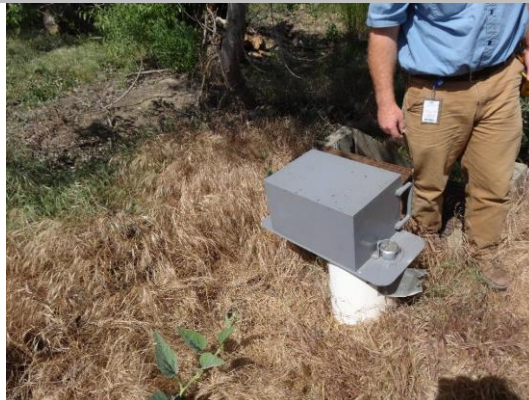
Photo 2 of 2 : UCIP\_SP\_2016\_35764\_64466.jpg

Locked box (unknown purpose) located on waterward side.

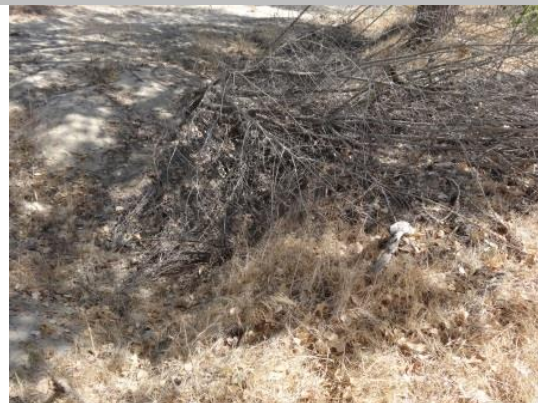
Photo 1 of 2 : SP\_2016\_NA0011\_143\_1\_20160223\_00001.jpg

Debris at the site.

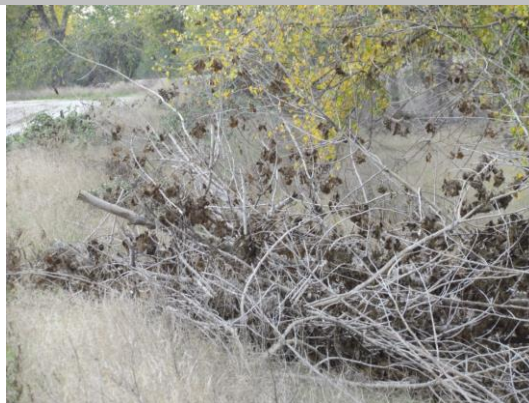
Photo 1 of 1 : SP\_2016\_NA0011\_143\_43\_20160223\_00010.jpg

Dead fallen tree not removed from levee section, reported in Spring inspection. Dead tree reported last spring not removed.

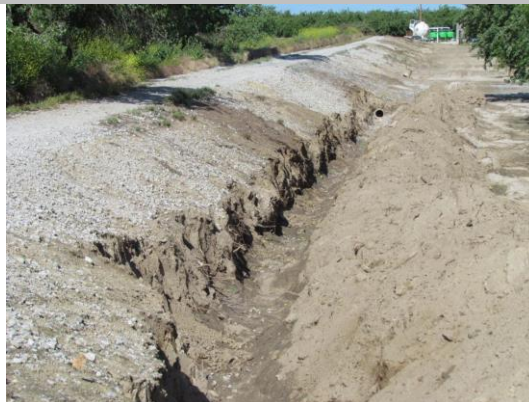
Photo 1 of 4 : SP\_2016\_NA0011\_143\_31\_20160425\_00033.jpg

Looking upstream from the landside slope pipe work being performed.

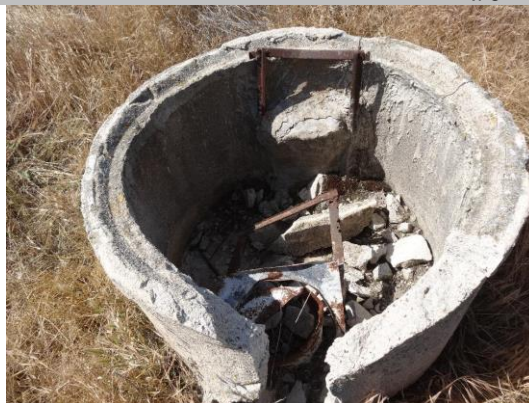
Photo 2 of 2 : UCIP\_SP\_2016\_39925\_71820.jpg

36-inch pipe full of concrete debris located on waterward side.

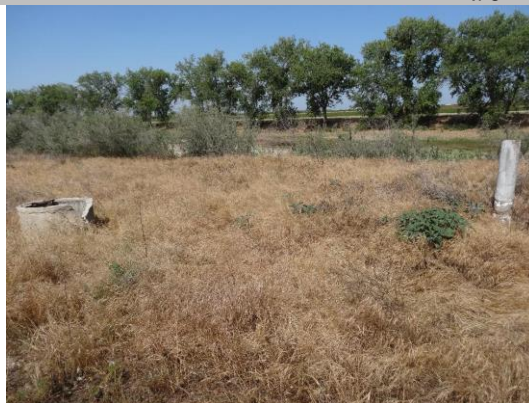
Photo 2 of 2 : UCIP\_SP\_2016\_39924\_71808.jpg

Concrete standpipes visible on waterward side--dense vegetation on waterward side.

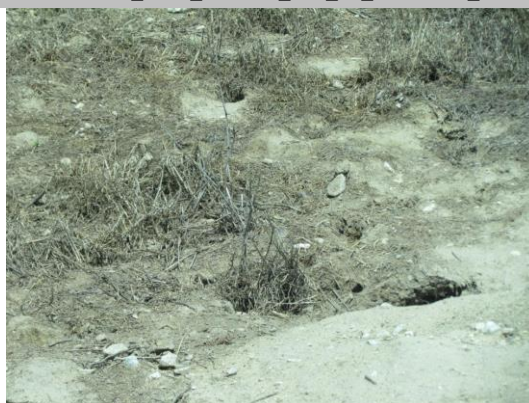
Photo 1 of 3 : SP\_2016\_NA0011\_144\_41\_20160426\_00020.jpg

Looking along the landward slope levee mile 0.71-1.51 an active infestation of rodents present.

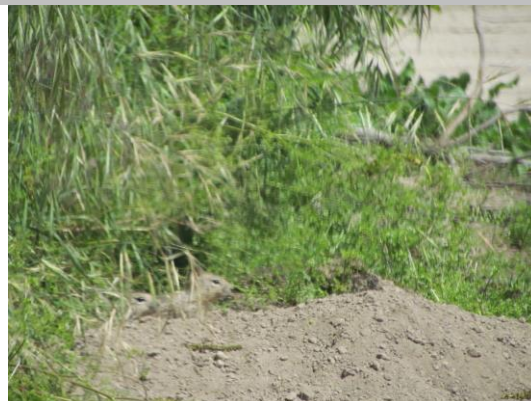
Photo 2 of 3 : SP\_2016\_NA0011\_144\_41\_20160426\_00022.jpg

Active colony of rodents in process of borrowing in the levee section.

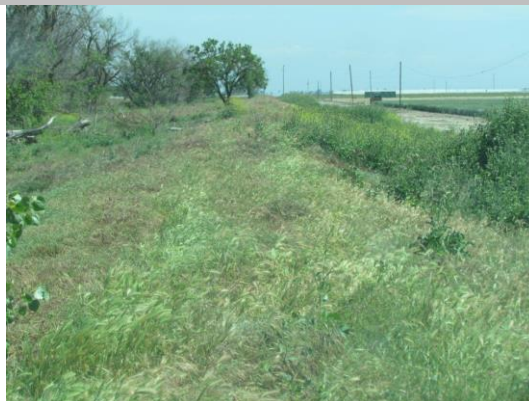
Photo 1 of 1 : SP\_2016\_NA0011\_145\_5\_20160428\_00018.jpg

Looking at the crown roadway from levee mile 0.01- 1.49 the tall weeds has covered the levee section.

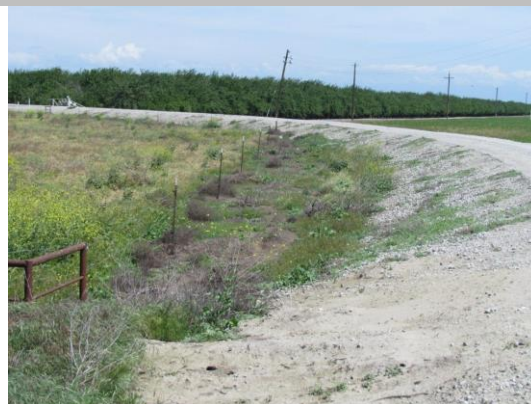
Photo 1 of 1 : SP\_2016\_NA0011\_145\_56\_20160428\_00016.jpg

Fence within 10-foot of the levee toe waterside.

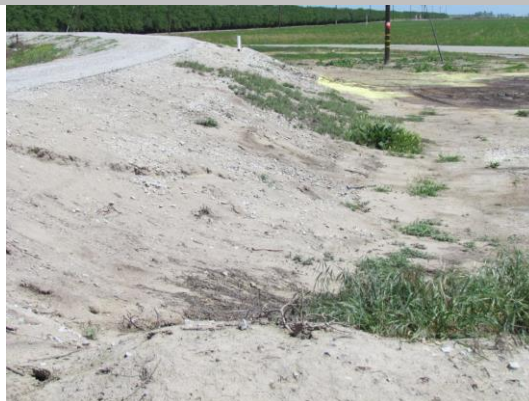
Photo 1 of 2 : SP\_2016\_NA0011\_145\_9\_20160428\_00015.jpg

Levee mile 1.51 landside slope damaged by the landowner.

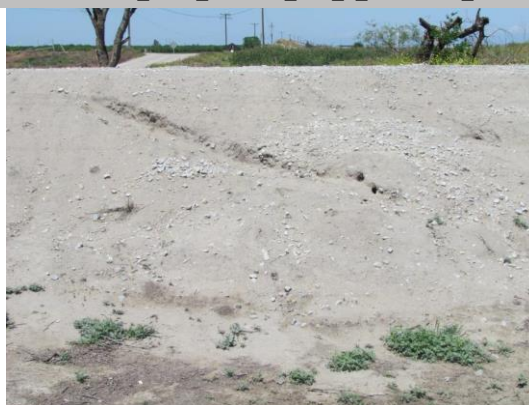
Photo 2 of 2 : SP\_2016\_NA0011\_145\_9\_20160428\_00013.jpg

Another view of the slope damage.

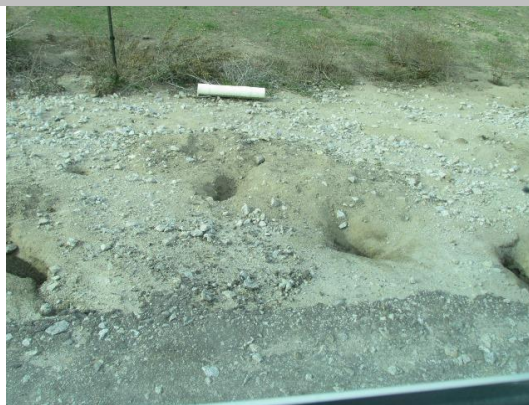
Photo 2 of 2 : SP\_2016\_NA0011\_145\_30\_20160223\_00010.jpg

Berenda Slough looking downstream from levee mile 1.65 waterside large rodent holes on slope.

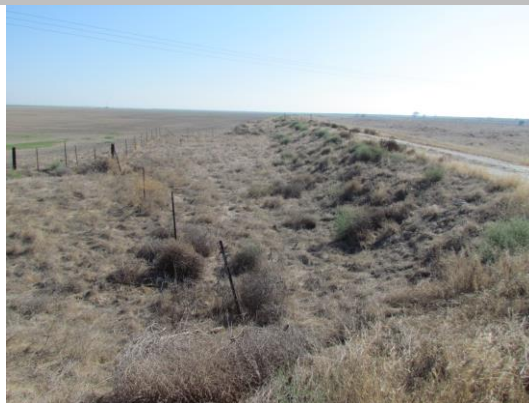
Photo 1 of 1 : SP\_2016\_NA0011\_146\_7\_20160502\_00020.jpg

Fresno River levee mile 0.00 looking upstream landside levee slope and toe covered with tall weeds.

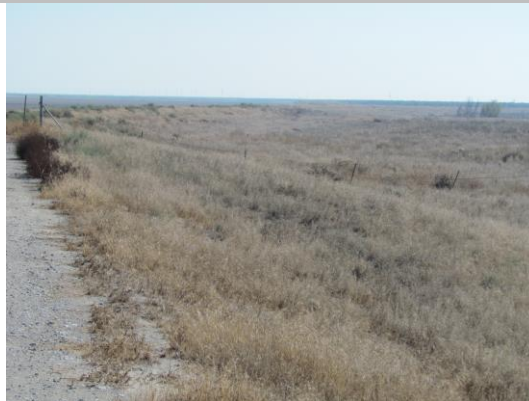
Photo 1 of 1 : SP\_2016\_NA0011\_146\_9\_20160502\_00022.jpg

Fresno River levee mile 0.00 looking upstream to levee mile 4.06  
waterside slope and toe is covered with wild growth.

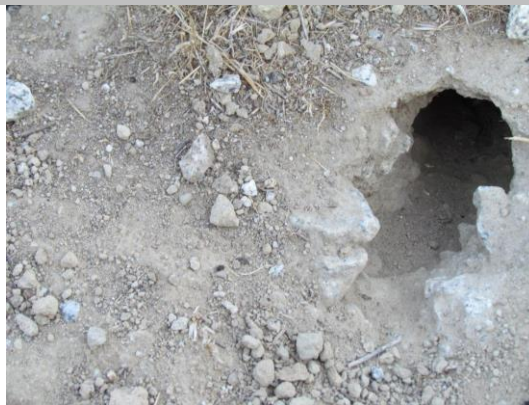
Photo 2 of 2 : SP\_2016\_NA0011\_146\_24\_20160223\_00006.jpg

Crown road way levee mile 2.80 to 3.23 covered with active rodent holes.

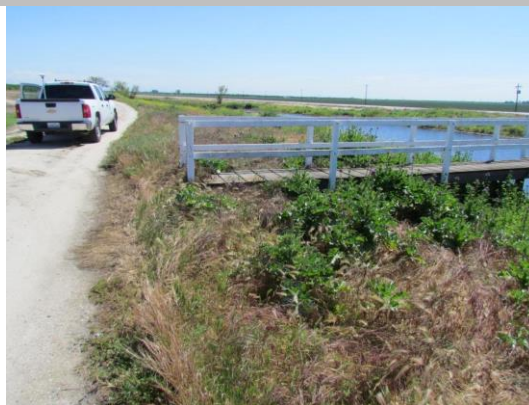
Photo 1 of 1 : SP\_2016\_NA0011\_146\_28\_20160502\_00029.jpg

Looking upstream from levee mile 6.59- 9.08 waterside slope covered with tall weeds.

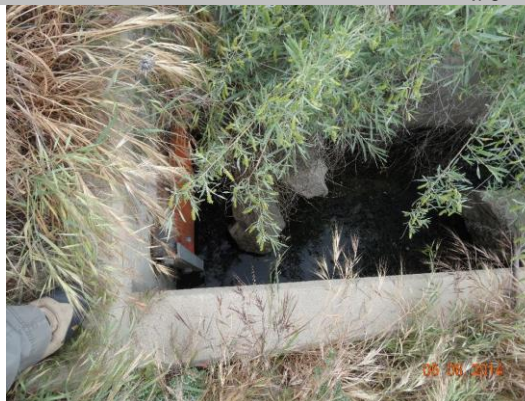
Photo 2 of 2 : UCIP\_SP\_2016\_38235\_69721.jpg

Concrete headwall visible on waterward side and covered by dense vegetation.

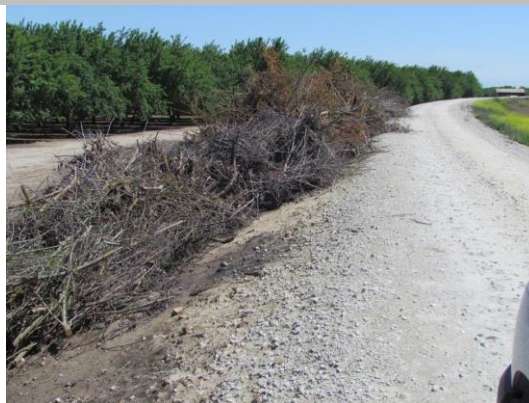
Photo 1 of 1 : SP\_2016\_NA0011\_146\_35\_20160502\_00026.jpg

Looking upstream at the hugh brush pile covering the landside slope, shoulder and toe.

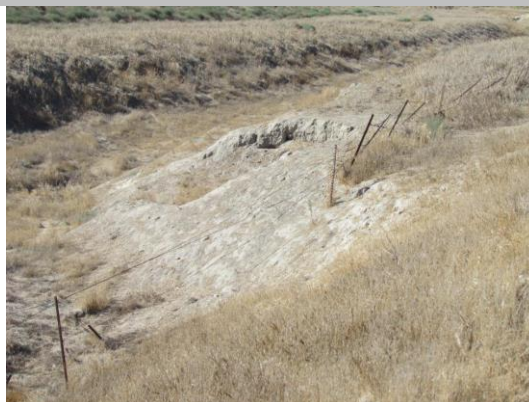
Photo 1 of 1 : SP\_2016\_NA0011\_147\_20\_20160223\_00002.jpg

Looking upstream at the old erosion site landside slope.

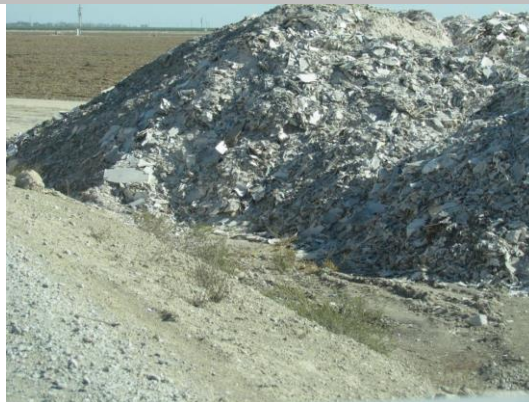
Photo 1 of 1 : SP\_2016\_NA0011\_147\_1\_20160223\_00001.jpg

Recycle sheet rock piles within the landside easement.

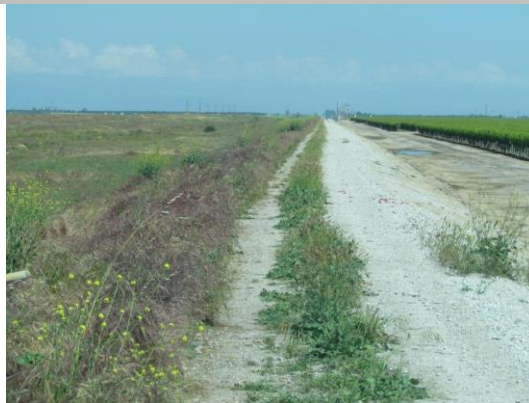
Photo 1 of 1 : SP\_2016\_NA0011\_147\_17\_20160502\_00035.jpg

Looking upstream from levee mile 2.49-3.68 weeds present on the crown roadway.

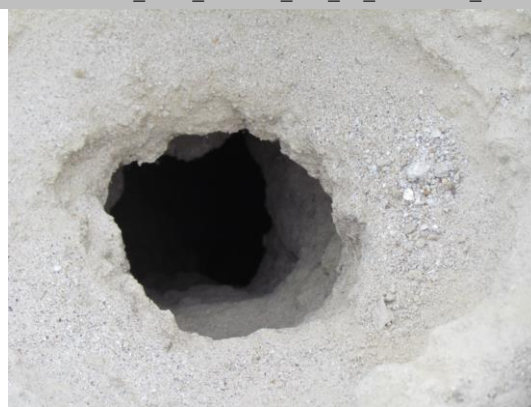
Photo 1 of 1 : SP\_2016\_NA0011\_147\_48\_20160223\_00011.jpg

Huge Rodent hole in crown roadway and many other holes at this location on the slope and toe.

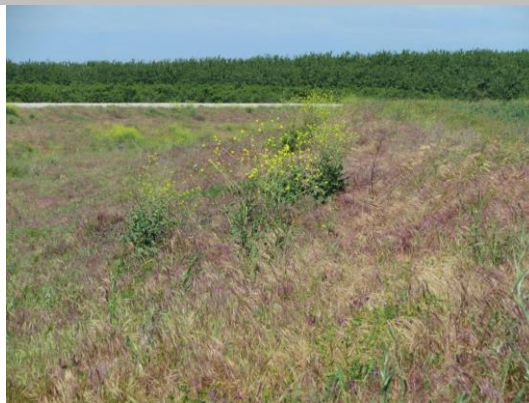
Photo 1 of 1 : SP\_2016\_NA0011\_147\_21\_20160502\_00037.jpg

Looking upstream from levee mile 7.70 -8.53 weeds taller than 3.0 foot covering the slope and toe.

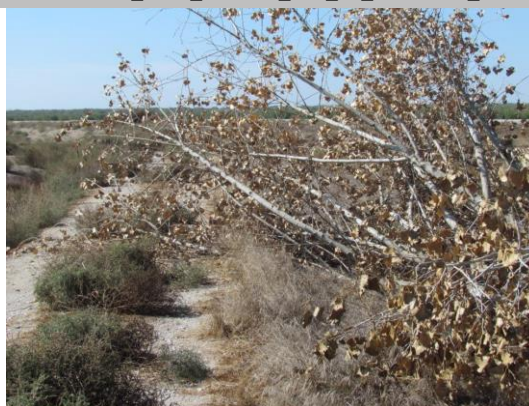
Photo 1 of 1 : SP\_2016\_NA0011\_147\_36\_20160223\_00006.jpg

Dead tree pushed upon the waterside slope and blocking the crown.

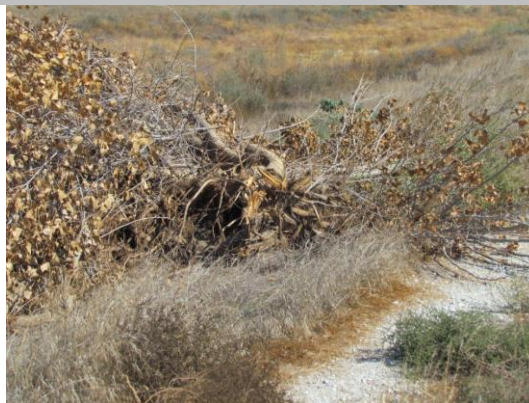
Photo 1 of 1 : SP\_2016\_NA0011\_147\_31\_20160223\_00005.jpg

Fresno River looking downstream from levee mile 8.09 dead tree blocking the crown roadway.

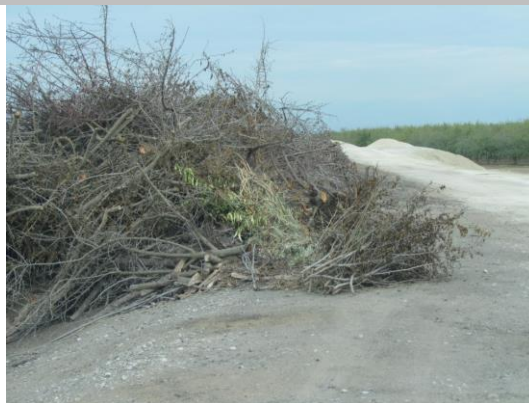
Photo 1 of 1 : SP\_2016\_NA0011\_147\_43\_20160223\_00008.jpg

Tree pruning's on the waterward levee shoulder blocking section of crown. Completely has the slope blocked on waterward side.
